DOT/FAA/RD-92/8

Performance of Insulated Pavements at Newton Field, Jackman, Maine

Maureen A. Kestler
Richard L. Berg

May 1992

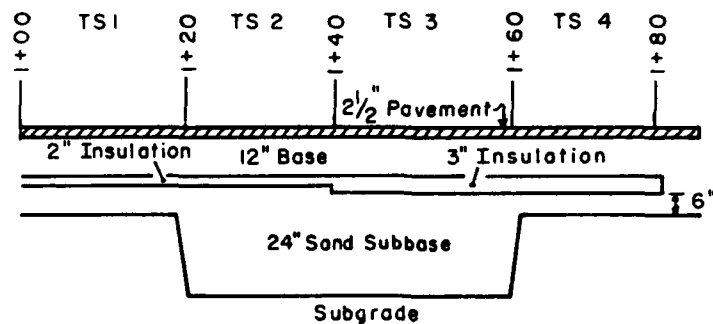
Figure 5. Longitudinal section of the insulated test sections.

adjacent to the aircraft parking apron in July 1987. The test section site was wet, but was not as swampy as much of the runway site. Figure 5 shows a longitudinal section at the test sections. The pavement consists of 2½ in. of bituminous concrete, 12 in. of aggregate base course, and 2- and 3-in.-thick layers of extruded polystyrene insulation in combination with 6 and 24 in. of sand subbase. Test section 1 most closely approximates the design used for the insulated runway. In contrast to single-thickness insulation panel placement in the runway, insulation panels in the test sections were placed in multiple layers with joints staggered as shown in Figure 6. The soil profile is the same as that of the Newton Field runway (Fig. 3a).

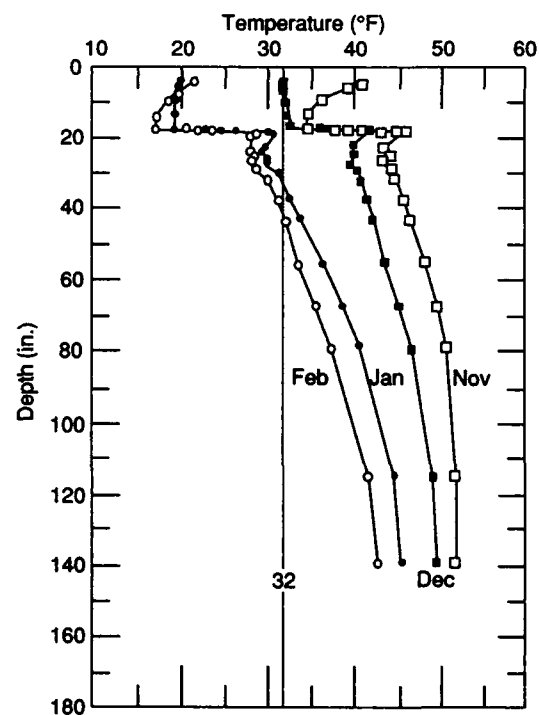
d. Subsurface temperatures at Newton Field, station 4+50, winter 1987-1988.

A distinct temperature discontinuity occurs immediately beneath the insulation on the runway (Fig. 13d). Two vertical thermocouple assemblies, one located both in and above the insulation and the second located entirely below the insulation, are separated horizontally by approximately 5 ft. It is believed that the temperature discontinuity between the thermocouple assemblies is caused either by damage to the insulation or by the horizontal separation of the insulation panels. The problem probably occurred during construction. Evidence of this problem was encountered during construction near stations 4+50 and 8+00. At both locations, trucks, bulldozers, and other construction traffic caused a large subgrade "flow" that in turn raised the insulation. Under

direction of the resident engineer, the insulation was removed, the subgrade was removed to the desired depth, and the geotextile, insulation, and base course were all replaced.

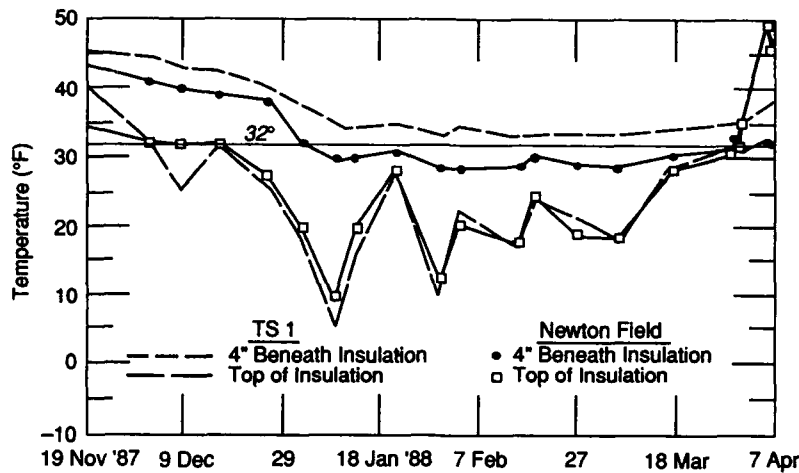
Figure 14. Comparison of temperatures above and beneath the insulation at Newton Field and in test section 1.

The difference in insulating ability of the insulation at the two pavement sites is also seen in Figure 14. Although the temperatures at the top of the insulation at each site are comparable, 4 in. beneath the insulation the temperatures differ substantially and fairly consistently over time. For winter 1987–1988, the 32°F isotherm never penetrated to this depth at the test sections, but at a comparable depth at the runway, the temperature remained below 32°F for nearly three months. This performance was the same for all three winters during which subsurface temperatures were obtained at both sites.

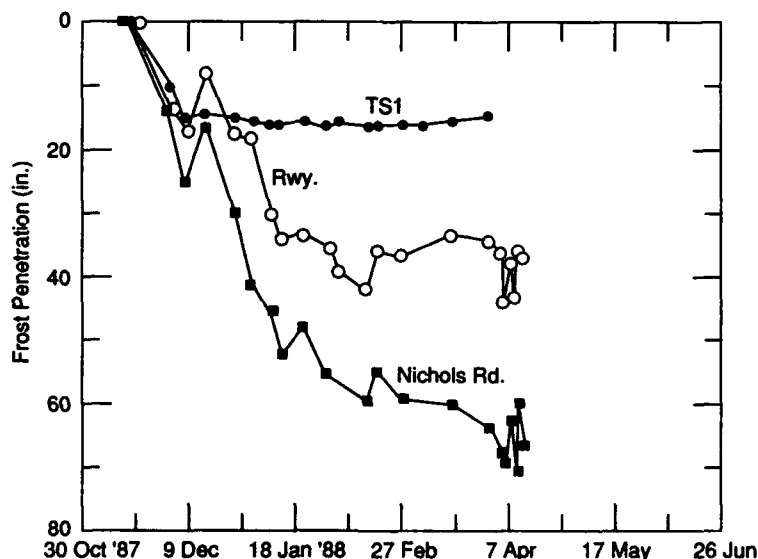
Figure 15. Progression of frost penetration with time, winter 1987–1988.

The progression of frost penetration with time is shown in Figure 15. For the 1987–1988 winter, the insulated pavement at the runway (station 4+50) allowed approximately 2 ft of frost penetration beneath the insulation. Although appreciably less than at noninsulated Nichols Road, the actual frost depth far exceeded all estimates. The unexpected frost penetration beneath the insulation on the runway during winter 1986–1987 constituted the primary reason for installation of the test sections in 1987. In contrast to the limited effectiveness of the insulation at the runway, the insulation at test section 1 prevented frost from penetrating into the subgrade. While Figure 15 is based upon 1987–1988 data, the curves are representative of each year; frost never

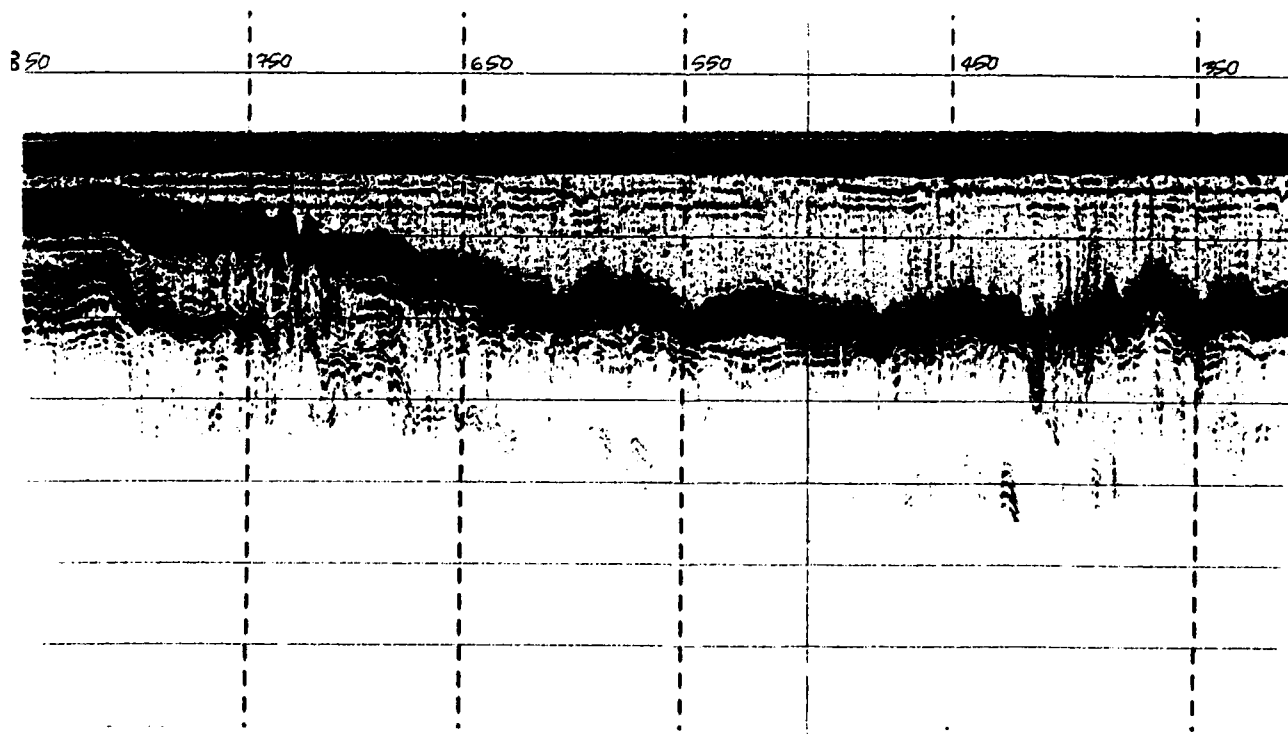
b. Centerline profile at west end of Newton Field, station 3+50 to station 8+50.

In contrast to the relatively uniform depth of the insulation panels at the test sections, Figures 22b and c show the irregular base course thickness and corresponding nonuniform depth of the insulation panels along the centerline at the two ends of the runway. For the insulation panels at shallow depths, the vertical stresses imposed by the design single-wheel load of 30 psi exceed the panels' 40 psi compressive strength. It is possible that this could lead to crushing of the insulation and ultimately lower the efficiency of the insulating layer. In Figure 22d, the individual 2-ft wide panels can be identified and are indicated on the figure.

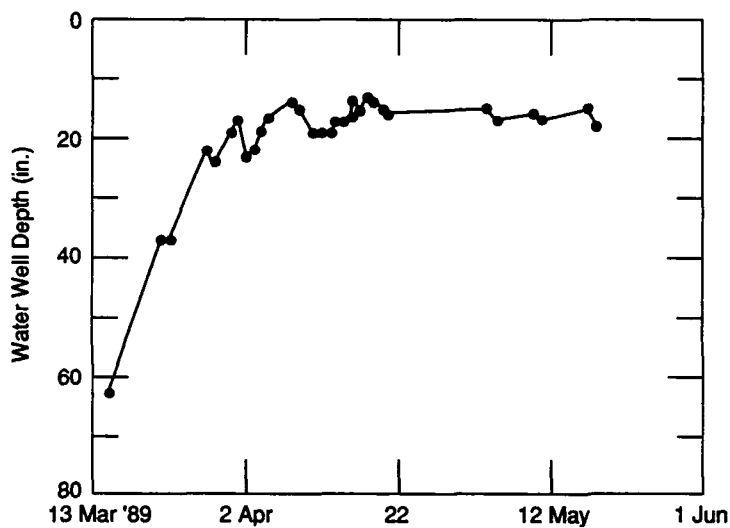
Figure 28. Water well depth at Newton Field, spring 1989.

2. The high groundwater table (Fig. 28) causes the subgrade to remain quite weak throughout the year.

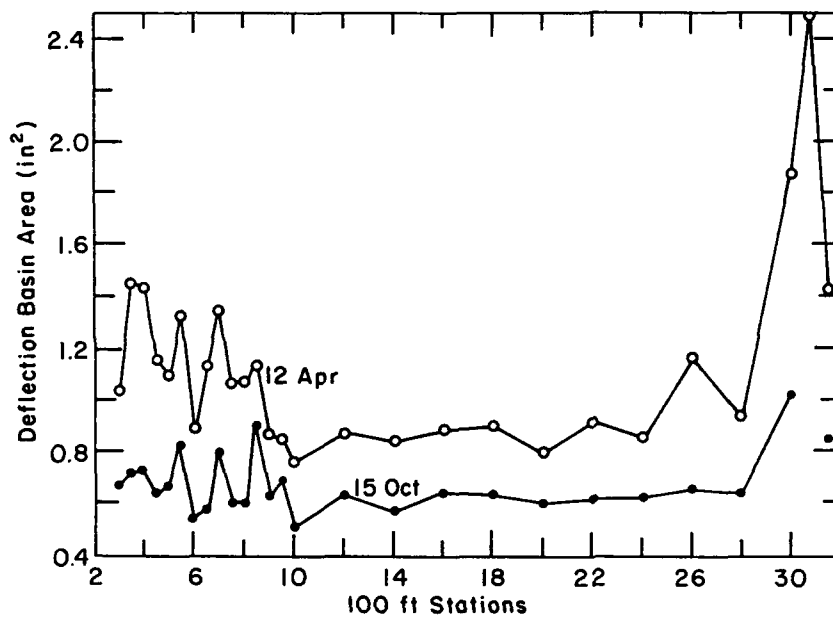
Figure 29. Deflection basin areas along the entire length of Newton Field, spring 1988.

Deflection basin areas along the entire length of the runway are shown in Figure 29 for winter-spring 1987-1988. The largest deflection basin areas coincide with locations that experienced excessive frost heave and areas where the subbase was generally around 6 in. thick.
